## Completion Report

Project Name:	Corkwood Bore HHIP
Property Address:	House 2, Corkwood Bore

Ingkerreke Services Aboriginal Corporation (ISAC) conducted housing upgrades to House 2 Corkwood ore on behalf of the Corkwood Bore Homeland and the NT Government.

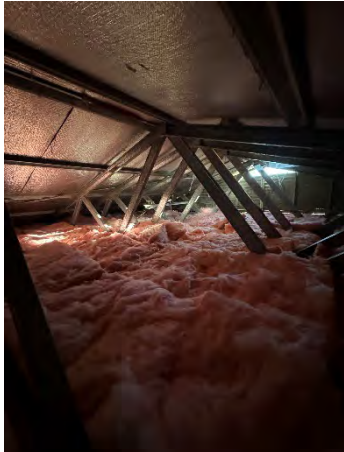
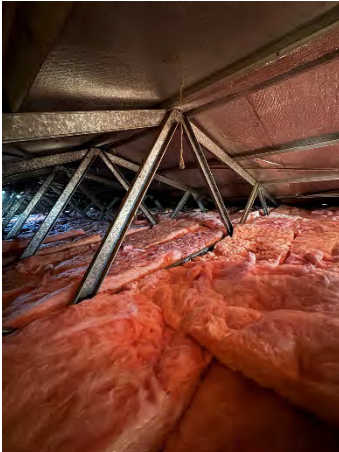
Insulation Installed:
